**Flood Control Project Maintenance
Levee Inspections**
LMA District Cover Sheet
Spring 2020 Levee Inspection Results

Madera County FCWCA

Spring 2020 Levee Inspection Results

Waterway			Bank	Unit Miles
Unit No. 01 Ash Slough			Right	2.37
	Spring (March - May)	Summer (June - August)	(September - November) Fall	Winter (December - February)
Unit Maintenance Rating (Fall Only)				
Date of Inspection	4/14/2020 - 4/14/2020			
DWR Inspector	Corey Fujitani			
Accompanied By

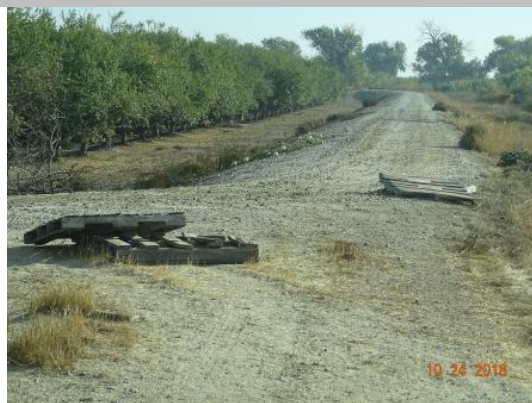
Photo 2 of 2 : SP_2020_NA0011_142_15_20200225_00008.jpg

Pallets left on levee crown. (Fall 2018)

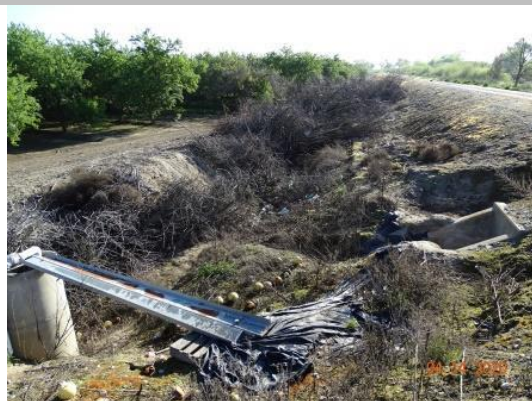
Photo 1 of 2 : SP_2020_NA0011_142_18_20200417_00034.jpg

LM Start	0.03	Rating **	U	Issue No.	18
LM End	0.06	Issue Type +	En	Location *	LS
Category	Earthen Levee			GPS Latitude/Longitude	
				Start	End
Item	Encroachments			37.046566 °	37.046715 °
				-120.427512 °	-120.426964 °
DWR ID	DWR_NA0011_01_s_2014_18				
Comment Code					
DT : Ditch					
Inspector Comment					
There seem to be lots of activity going on at this location. This ditch will cause more damage to the levee slope and toe.

Looking upstream at existing ditch along the landside toe. (Spring 2020)

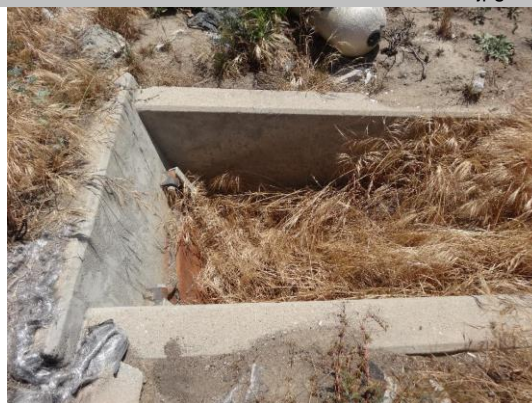
Photo 2 of 3 : UCIP_SP_2020_53153_69673.jpg

DS_ID:21513
FS_ID:53153
EP_NO: N/A
Repair Type: Urgent
Crossing Status: Found
UCIP Comments: 10/31/2018 Erosion present on both the right and the left side of the concrete headwall located on the LS. Pipe inlet is about 50 percent filled with soil. WS outlet is at a low point, water will pond against the levee until it reaches channel elevation. This crossing does not properly drain to the channel. Levee is composed of highly erodible material. Recommend clearing soil from pipe and completing internal pipe inspection to determine pipe integrity through levee. (O. Magana - DWR UCIP)
07/14/2016 No inspection completed--need to inspect October 2016. (DWR UCIP - omagana)05/06/2014 Landward slope has been excavated and a berm built in front of landward headwall. Sediment visible inside pipe from landward side. Dense vegetation limits the inspector's visibility to identify signs of pipe failure (leaks) along the waterward slope. Recommend removing vegetation along pipe alignment and waterward headwall to conduct proper inspection of structure. (DWR UCIP - omagana)

Flap gate located on WS blocked by dense vegetation.

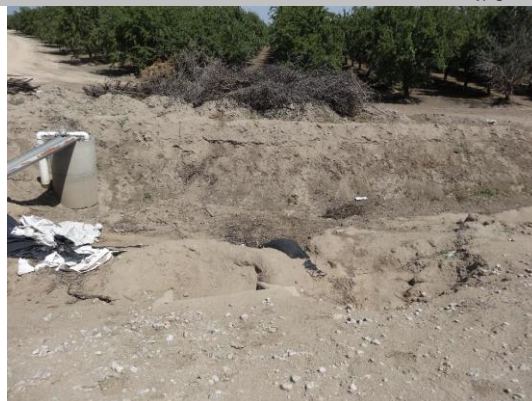
Photo 3 of 3 : UCIP_SP_2020_53153_69675.jpg

View of LS--levee slope has been modified.

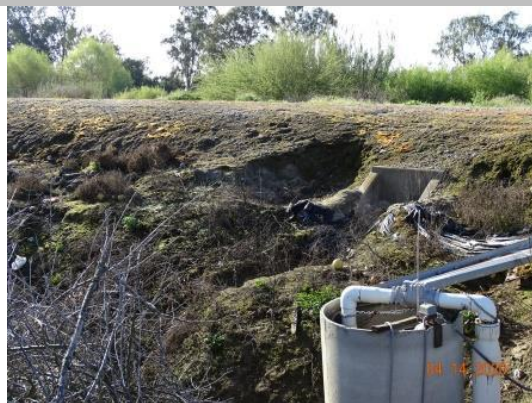
Photo 1 of 2 : SP_2020_NA0011_142_20_20200417_00036.jpg

LM Start	0.04	Rating **	U	Issue No.	20
LM End	0.04	Issue Type +	Ma	Location *	LS
Category	Earthen Levee			GPS Latitude/Longitude	
				Start	End
Item	Slope Stability			37.046624 °	37.046624 °
				-120.427317 °	-120.427317 °
DWR ID	DWR_NA0011_01_s_2014_20				
Comment Code					
S1 : Repair slope instability.					
Inspector Comment					
This is not a new erosion site, it should be repaired before the condition gets any worse.

View of slope damage next to pipe headwall structure. (Spring 2020)

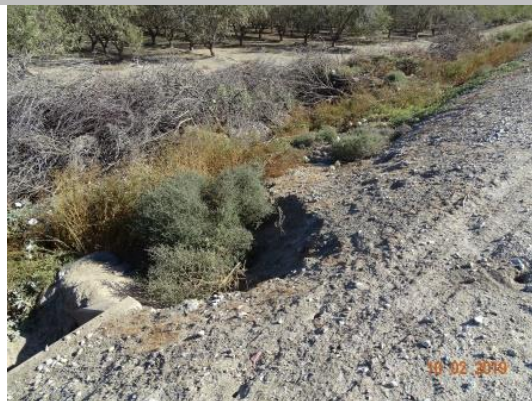
Photo 2 of 2 : SP_2020_NA0011_142_20_20200225_00010.jpg

View of damage to landside slope. (Fall 2019)

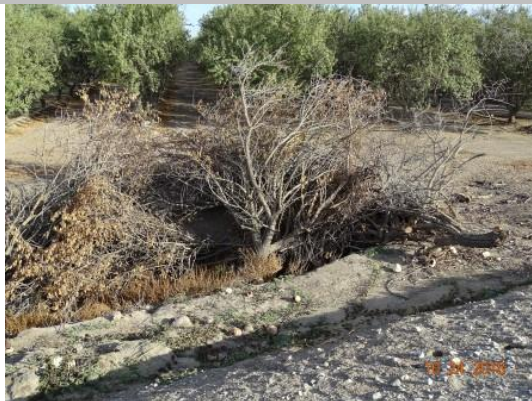
Photo 2 of 2 : SP_2020_NA0011_142_36_20200225_00020.jpg

View of prunings left on the landside slope. (Fall 2018)

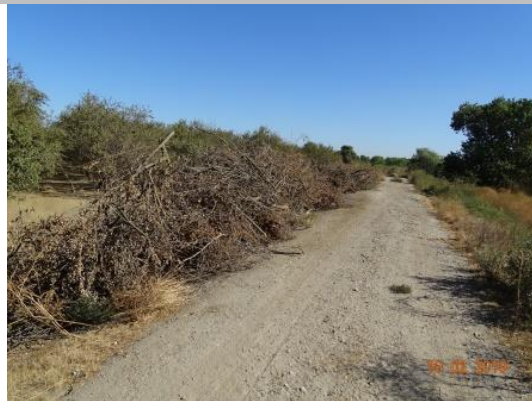
Photo 2 of 2 : SP_2020_NA0011_142_13_20200225_00003.jpg

Large pruning pile left on landside slope. (Fall 2019)

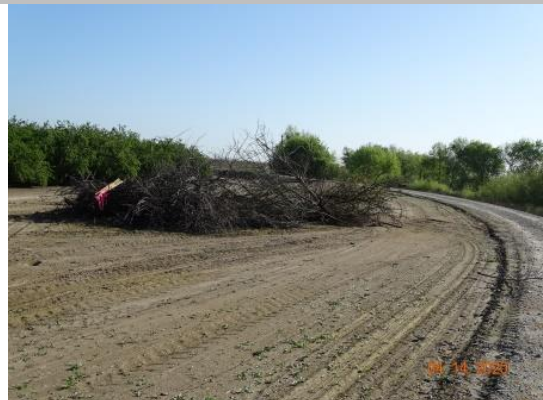
Photo 1 of 1 : SP_2020_NA0011_142_33_20200417_00043.jpg

Pruning piles left on the landside berm. (Spring 2020)

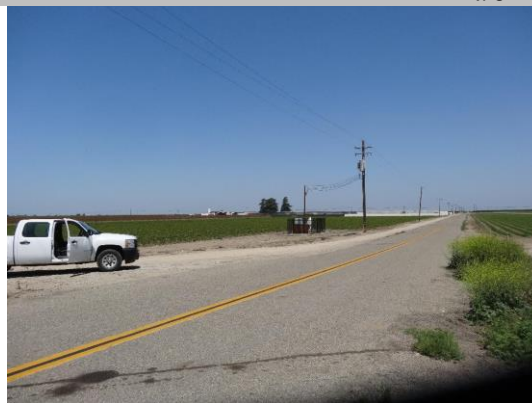
Photo 1 of 3 : UCIP_SP_2020_52847_71800.jpg

LM Start	2.10	Rating **	M	Issue No.	48
LM End	2.10	Issue Type +	En	Location *	
Category	Supplemental			GPS Latitude/Longitude	
				Start	End
Item	DWR UCIP Field Study			37.065649 °	37.065649 °
				-120.400663 °	-120.400663 °
DWR ID	25042				
Comment Code					
Inspector Comment					
DS_ID:25042 FS_ID:52847 EP_NO: N/A Repair Type: Non-Urgent Crossing Status: Found UCIP Comments: 05/06/2014 Need to contact owner to determine if crossing goes through levee. (DWR UCIP - O. Magana) FIELD_STRUCT_DESC: 10-inch or 12-inch drainage discharge pipe of an unknown material through the levee, at an unknown depth. Crossing visible inside a concrete standpipe on the waterside (WS). Potential pump station on the landside (LS), approximately 100 feet from the standpipe. This crossing was field discovered. FS Date: 5/6/2014

Pump station visible approximately 100 feet from concrete standpipe.

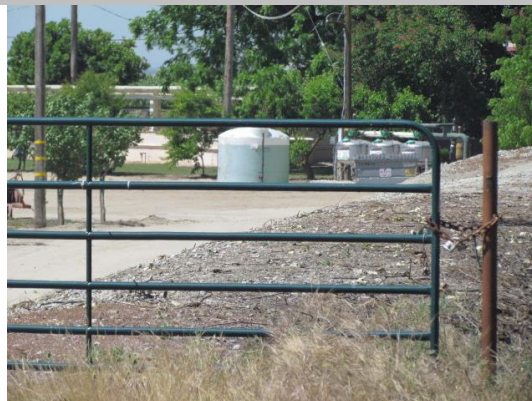
Photo 2 of 2 : SP_2020_NA0011_143_5_20200225_00005.jpg

This fence was not authorized by CVFPB. The District is aware of the fence. The landowner installed the fence and gate across the levee section because he has been broken into frequently and had many items stolen in the past. An inspector met with the landowner on 4-29-2014 and he let the inspector put a State lock on his gate to gain access to the levee.

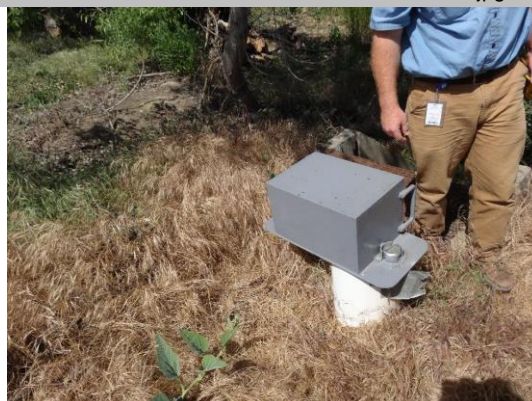
Photo 2 of 3 : UCIP_SP_2020_52834_64466.jpg

Comment Code						
Inspector Comment						
DS_ID:21514 FS_ID:52834 EP_NO: N/A Repair Type: Non-Urgent Crossing Status: Found UCIP Comments: 05/06/2014 Need to contact owner to determine details of crossing and permit information authorizing crossing. Dense vegetation limits the inspector's visibility to identify signs of pipe failure (leaks) along the slope. Recommend removing vegetation along pipe alignment to conduct proper inspection of structure and appurtenances. (DWR UCIP - O. Magana) FIELD_STRUCT_DESC: Gravity drainage pipe of an unknown size or material through the levee, at a skew and at an unknown depth. Concrete discharge structure at the waterside (WS) end. Standpipe with gage house off the landside (LS) toe. No gage house found on the LS during inspection. [Additional Reference(s): DWR Levee Log, 2005]. FS Date: 5/6/2014

Locked box (unknown purpose) located on waterward side.

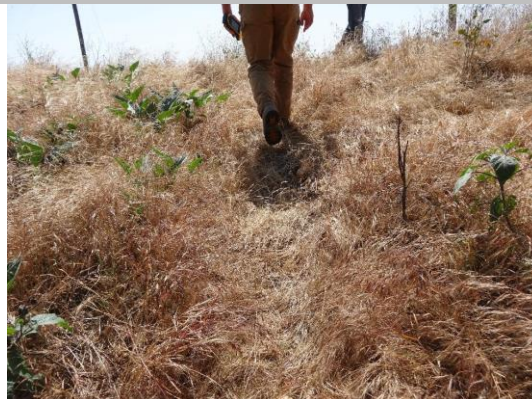
Photo 3 of 3 : UCIP_SP_2020_52834_64465.jpg

Dense vegetation on waterward slope.

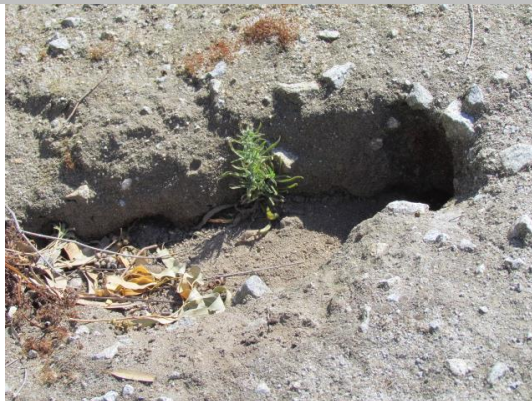
Photo 2 of 2 : SP_2020_NA0011_143_39_20200225_00029.jpg

Other rodent holes noted in the slope waterside levee section.

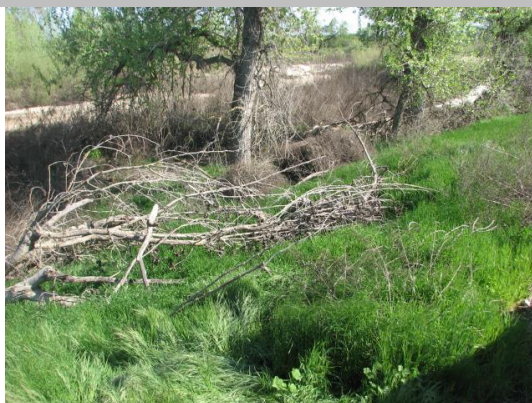
Photo 1 of 1 : SP_2020_NA0011_143_28_20200225_00022.jpg

Looking downstream at tree limbs on waterward slope and toe. (Spring 2018)

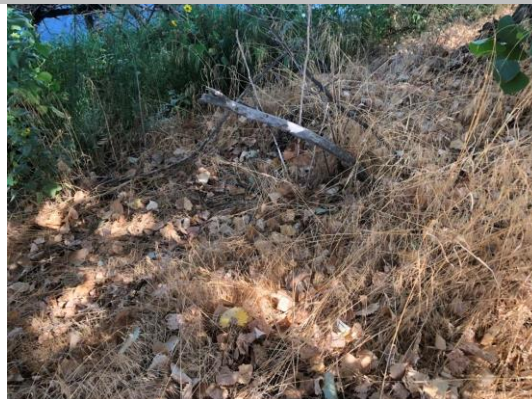
Photo 1 of 1 : SP_2020_NA0011_143_1_20200225_00001.jpg

View of the erosion site from the levee crest.

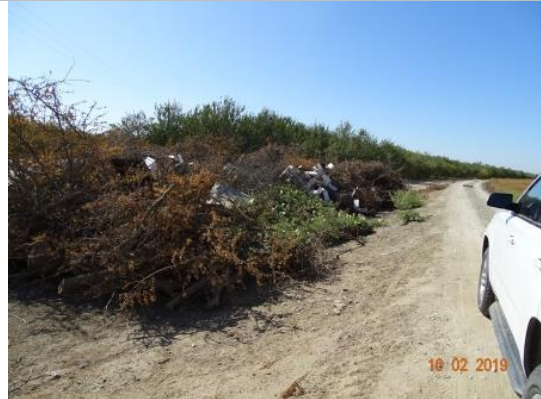
Photo 1 of 1 : SP_2020_NA0011_143_24_20200225_00017.jpg

View of prunings and trash piled along the landside levee toe. (Fall 2019)

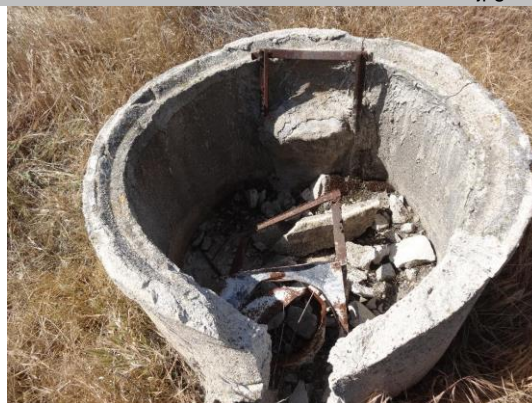
Photo 2 of 3 : UCIP_SP_2020_52844_71820.jpg

36-inch pipe full of concrete debris located on waterward side.

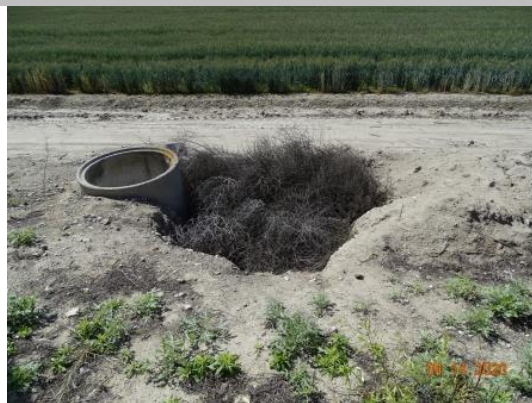
Photo 1 of 1 : SP_2020_NA0011_145_22_20200420_00032.jpg

Looking west at large hole next concrete riser (no pipe) on landward slope. (Spring 2020)

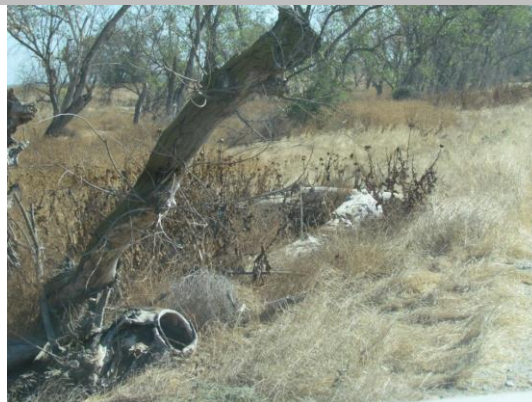
Photo 1 of 1 : SP_2020_NA0011_145_16_20200225_00015.jpg

Tree on WS shoulder.

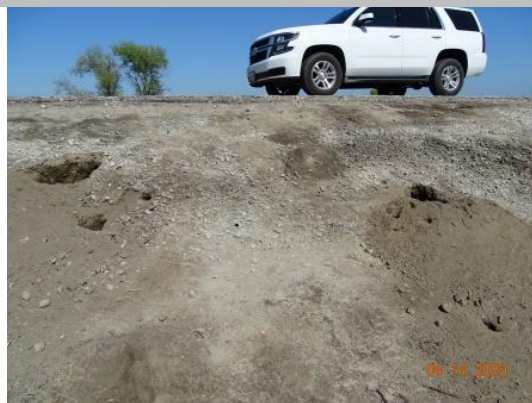
Photo 1 of 1 : SP_2020_NA0011_145_11_20200420_00035.jpg

Representative view of rodent holes observed in this section. (Spring 2020)

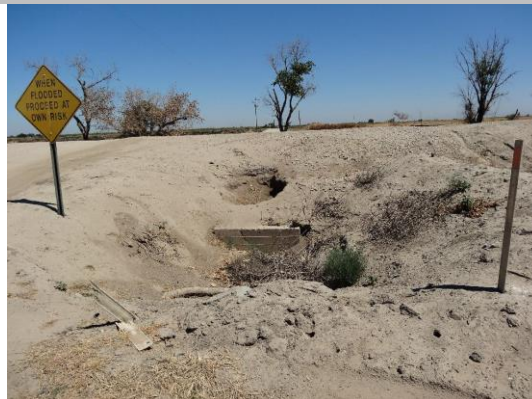
Photo 2 of 3 : UCIP_SP_2020_53154_75761.jpg

Sink hole and concrete headwall damage is visible on LS.

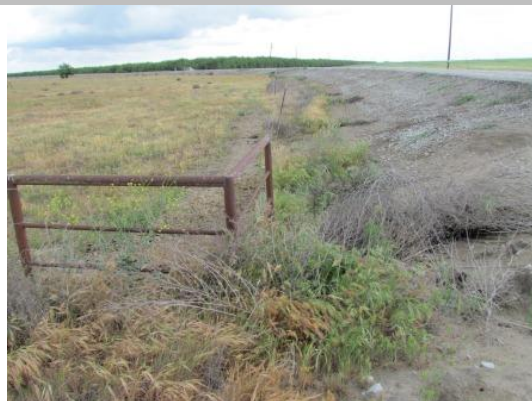
Photo 1 of 1 : SP_2020_NA0011_145_56_20200225_00027.jpg

Fence within the 10-foot of levee toe. This encroachment was recorded on 11-01-2012. Photo was taken 4-24-2014.

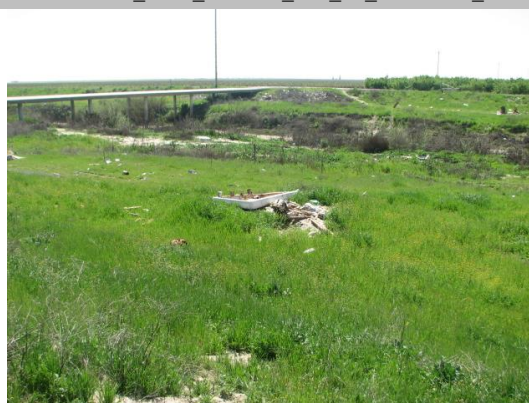
Photo 1 of 1 : SP_2020_NA0011_146_19_20200225_00015.jpg

Looking west at garbage in channel. (Spring 2018)

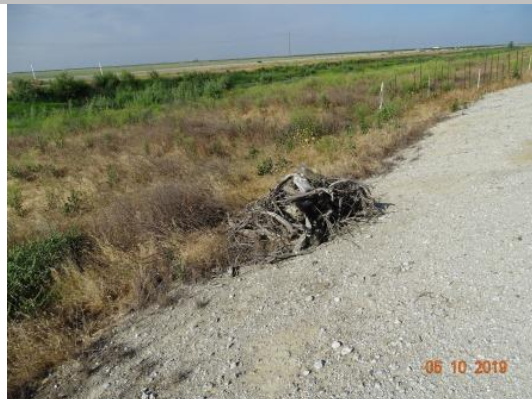
Photo 1 of 1 : SP_2020_NA0011_146_43_20200225_00032.jpg

Pruning pile left on the waterside shoulder. (Spring 2019)

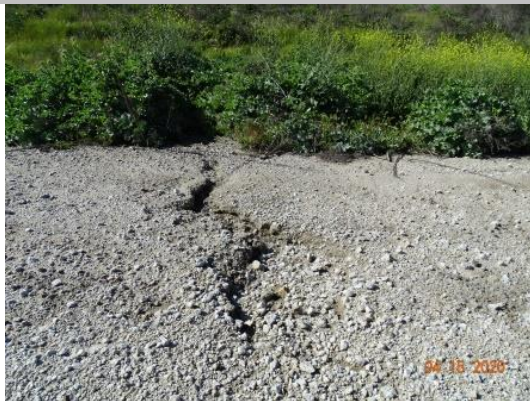
Photo 1 of 1 : SP_2020_NA0011_146_38_20200504_00057.jpg

Finger erosion on the waterside slope. (Spring 2020)

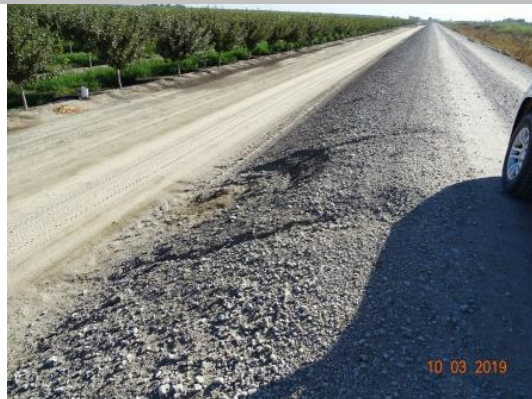
Photo 1 of 1 : SP_2020_NA0011_146_17_20200225_00011.jpg

View of landside slope erosion looking upstream. (Fall 2019)

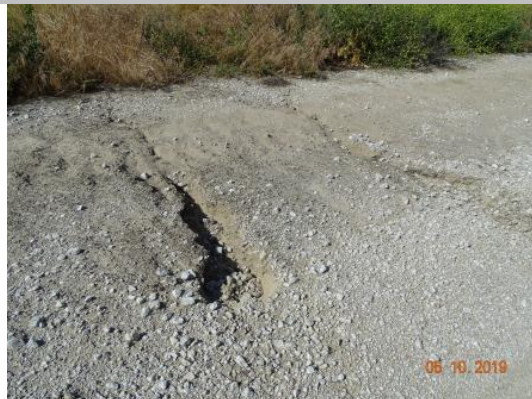
Photo 1 of 1 : SP_2020_NA0011_146_46_20200225_00033.jpg

Rills observed on waterside slope. (Spring 2019)

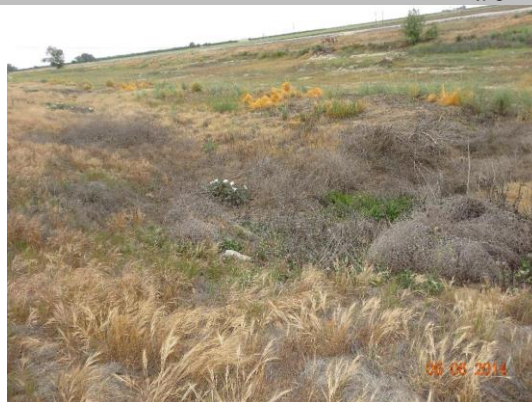
Photo 2 of 3 : UCIP_SP_2020_52859_69714.jpg

Concrete headwall covered by dense vegetation.

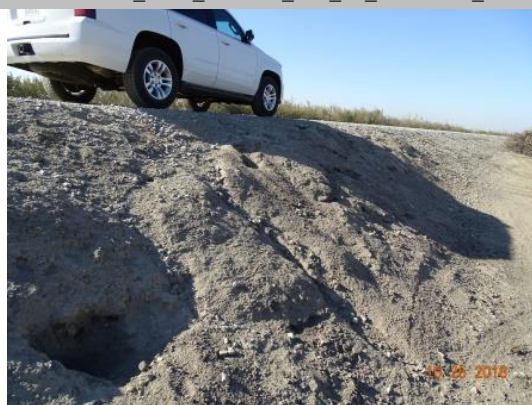
Photo 1 of 1 : SP_2020_NA0011_146_24_20200225_00016.jpg

Rodent activity on landside slope. (Fall 2018)

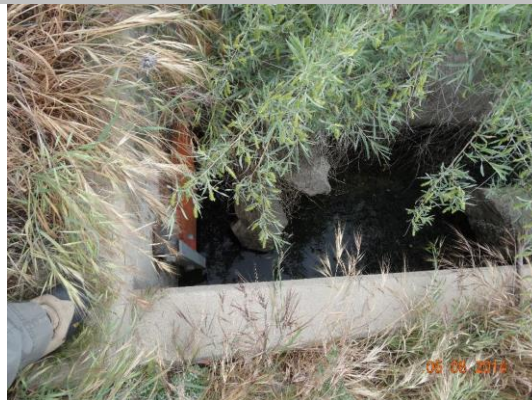
Photo 2 of 3 : UCIP_SP_2020_52863_69721.jpg

Concrete headwall visible on waterward side and covered by dense vegetation.

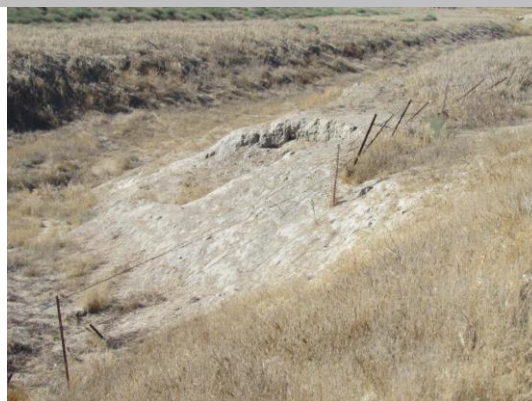
Photo 1 of 1 : SP_2020_NA0011_147_20_20200225_00008.jpg

Looking downstream at the old erosion site landside slope.

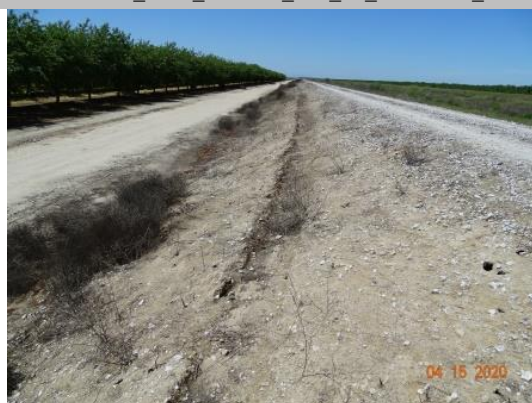
Photo 1 of 1 : SP_2020_NA0011_147_69_20200504_00059.jpg

Vehicle tracks in the landside slope. (Spring 2020)

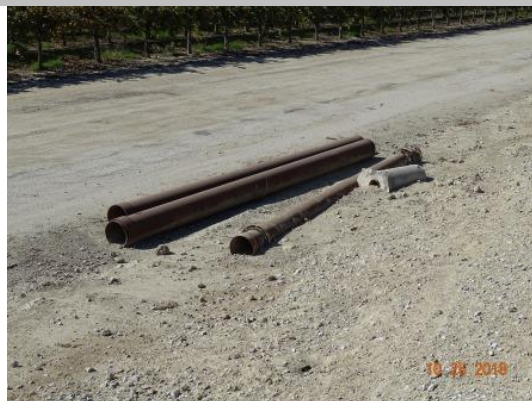
Photo 1 of 1 : SP_2020_NA0011_147_24_20200225_00011.jpg

Pipe segments left at levee toe. (Fall 2018)

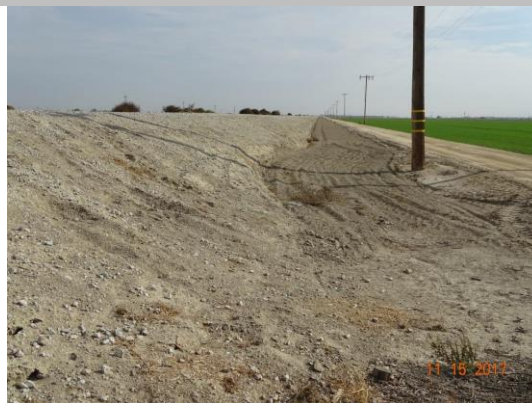
Photo 1 of 1 : SP_2020_NA0011_147_27_20200225_00012.jpg

Ag activity has cut into landside toe. Activity should be stopped and levee slope repaired.

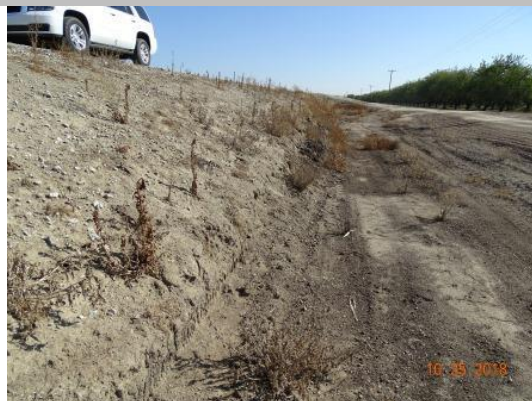
Photo 1 of 1 : SP_2020_NA0011_147_37_20200225_00017.jpg

Agricultural equipment cutting into levee slope. (Fall 2018)

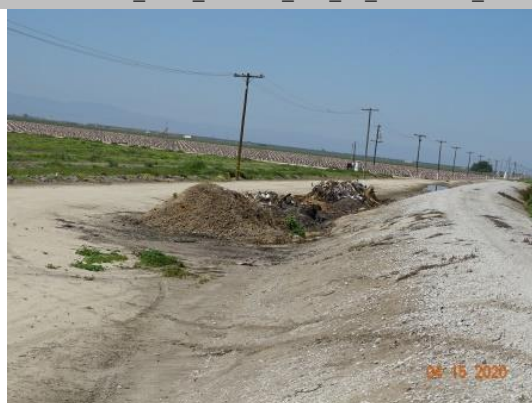
Photo 1 of 1 : SP_2020_NA0011_147_38_20200504_00065.jpg

View of debris pile and pruning piles along landside toe. (Spring 2020)

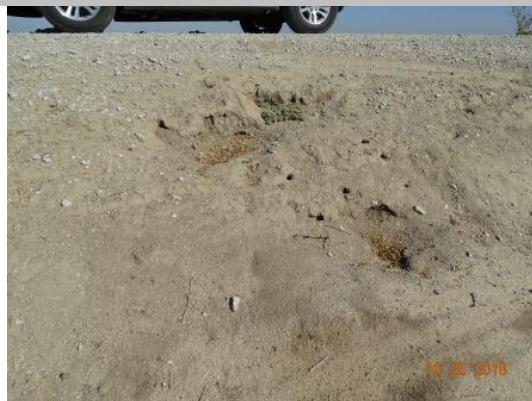
Photo 1 of 1 : SP_2020_NA0011_147_58_20200225_00031.jpg

Minor erosion on landside slope. (Fall 2018)

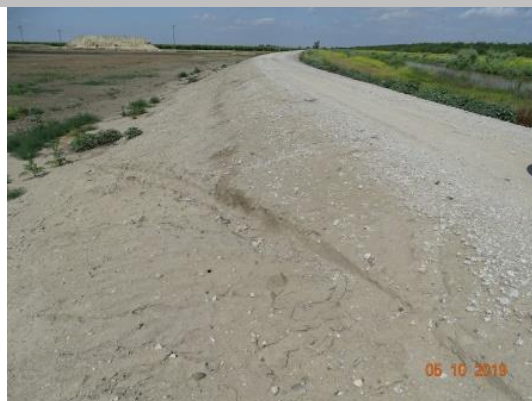
Photo 1 of 1 : SP_2020_NA0011_147_59_20200225_00032.jpg

View of vehicle tracks on landside slope. (Spring 2019)

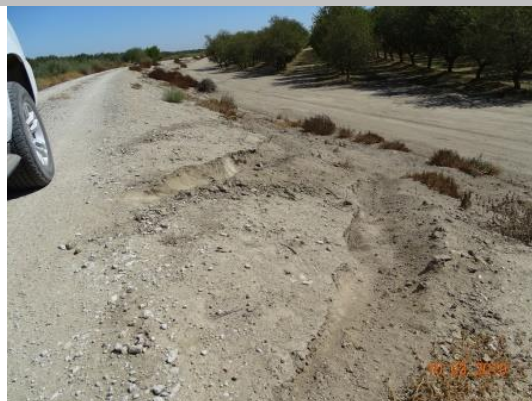
Photo 1 of 1 : SP_2020_NA0011_147_23_20200225_00010.jpg

Damage to landside slope from vehicle traffic. (Fall 2019)

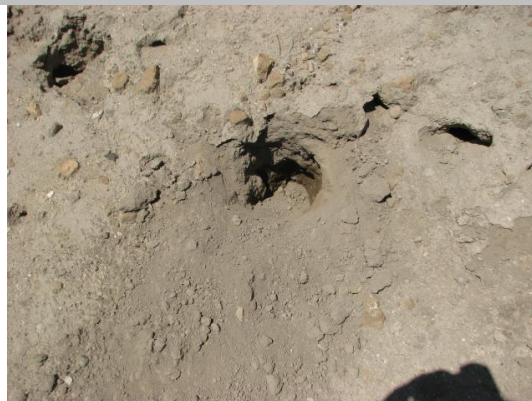
Photo 1 of 1 : SP_2020_NA0011_147_51_20200225_00024.jpg

Looking at typical rodent holes on landward slope. (Spring 2018)

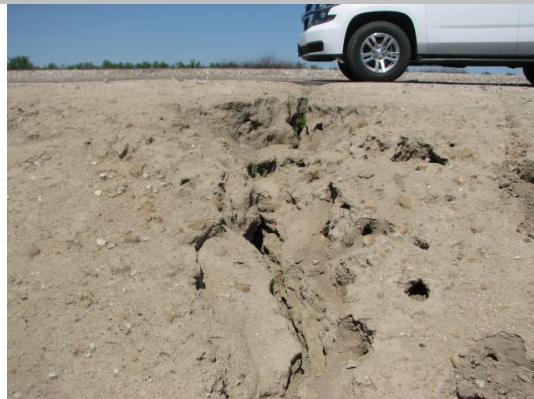
Photo 1 of 1 : SP_2020_NA0011_147_22_20200225_00009.jpg

Looking at finger erosion on landward slope. (Spring 2018)
